# FACILITY CONDITION ASSESSMENT

**Plainfield Public Schools**  
651 Norwich Road  
Plainfield, Connecticut 06374  
John Richards

Early Childhood Center  
651 Norwich Road  
Plainfield, Connecticut 06374

*October 31, 2023*

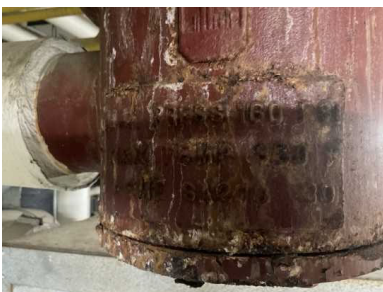
Air Separator, HVAC  
Early Childhood Center Boiler room

#### Supplemental Components in Poor condition.

The air separator is excessively aged and recommended for an upgrade. - AssetCALC ID: 6978174

Recommendation: **Replace in 2024**

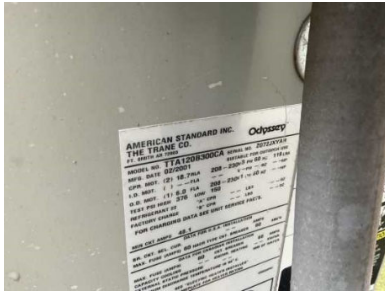
Condensing Unit/Heat Pump  
Early Childhood Center Building exterior

**Split System in Poor condition.**

The split system component is excessively aged and recommended for an upgrade. - AssetCALC ID: 6978152

Uniformat Code: D3030  
Recommendation: **Replace in 2024**

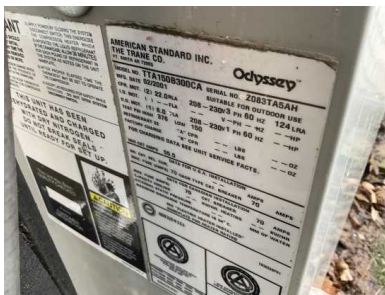
Condensing Unit/Heat Pump  
Early Childhood Center Building exterior

**Split System in Poor condition.**

The split system component is excessively aged and recommended for an upgrade. - AssetCALC ID: 6978200

Uniformat Code: D3030  
Recommendation: **Replace in 2024**

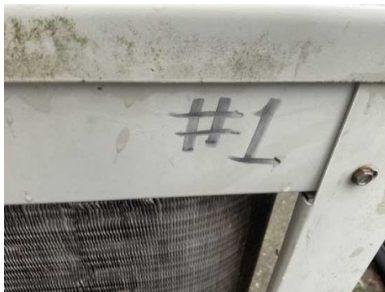
Condensing Unit/Heat Pump  
Early Childhood Center Building exterior

**Split System in Poor condition.**

The split system component is excessively aged and recommended for an upgrade. - AssetCALC ID: 6978176

Uniformat Code: D3030  
Recommendation: **Replace in 2024**
